USACERL Technical Report 98/47
February 1998

CONSTRUCTION PRODUCTIVITY ADVANCEMENT RESEARCH (CPAR) PROGRAM

Fiber-Reinforced Polymer Composite Materials Systems to Enhance Reinforced Concrete Structures

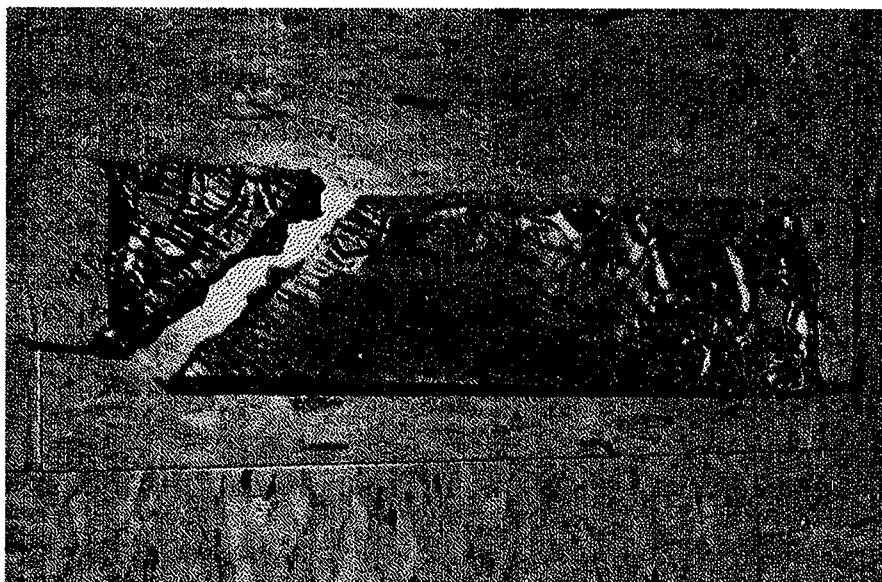
Figure E.62.1 - E.62.5 Diagonal shear crack propagation in the thermally cycled beams bonded with CFRP.

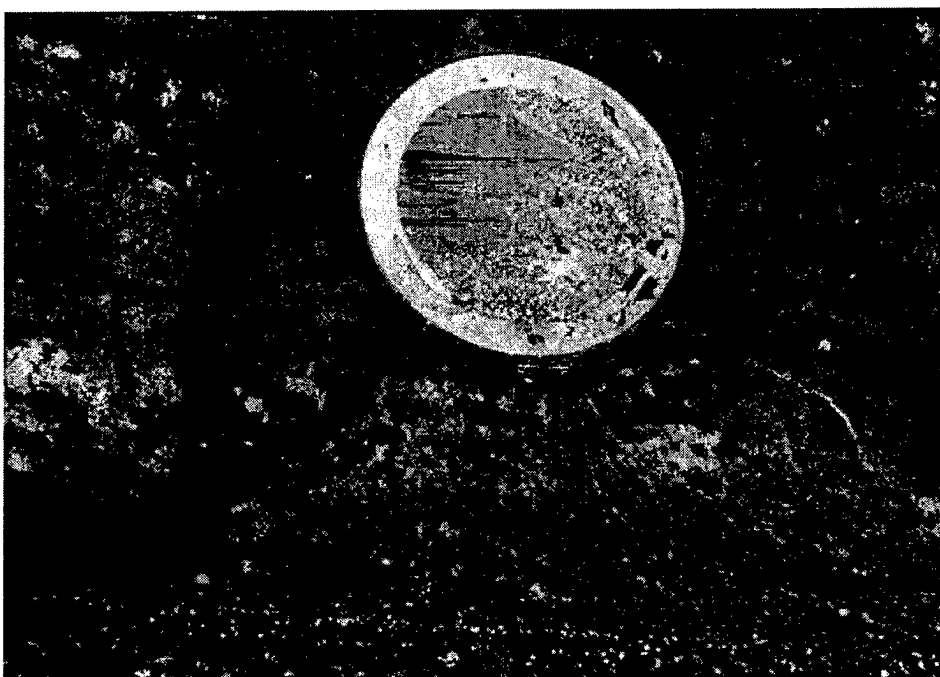
Figure F15b. Failure mode: between concrete and composite, and between steel disk and composite.

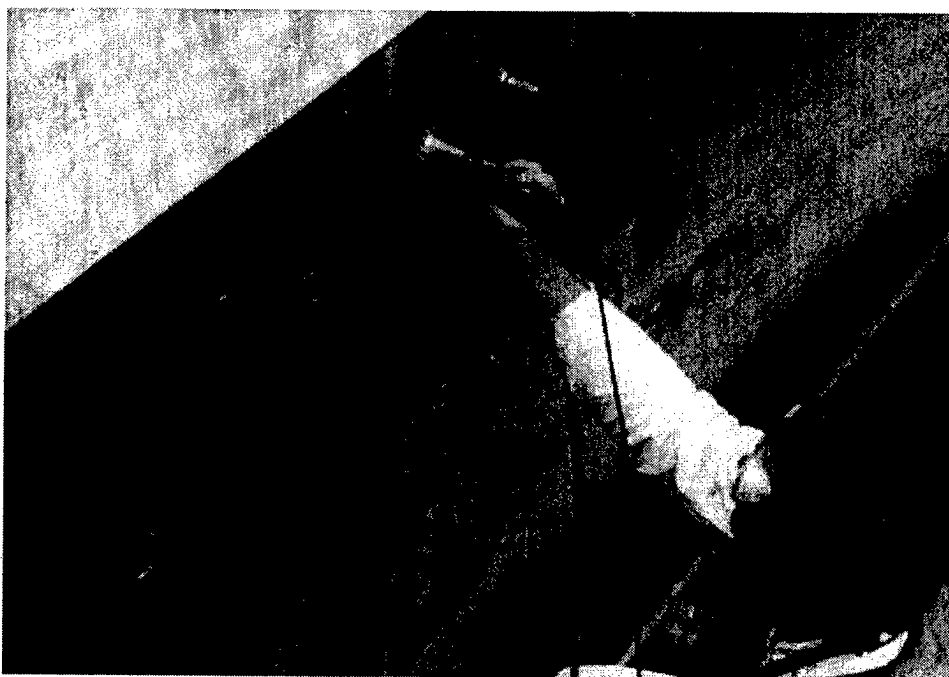
Figure F17b. Shear test.
